In re the Application of:)	
)	
PENG LEE and KEVIN SEDDON)	
)	
Serial No.: 10/708,571)	
)	
Filed: March 11, 2004)	
)	
For: NONDESTRUCTIVE RESIDENTIAL)	Attorney Docket No.:
INSPECTION METHOD AND)	1038406-000004
APPARATUS)

AMENDED APPEAL BRIEF

This invention provides an apparatus for nondestructive residential inspection and various methods for using a thermal imaging apparatus coupled to inspect exterior residential components, interior residential components, a pitched roof and basement of a residential building and the electrical system of a residential building.

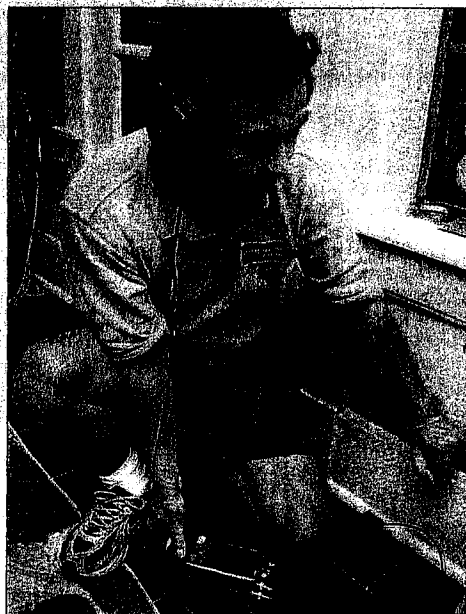
Peng Lee of HomeSafe Inspection uses a special sensor to listen for termites at the Judy Johnson home.
